CELL :- Tensioner CELL NAME:- A-157 MACHINE / STAGE :- Mazak (QUICK TURN 6G) OPERATION :- Boring Tapping & Facing

### KAIZEN THEME :-

To eliminate Thread defect Problem.

CELL :- oil Pump | CELL NAME:- A-316 | MACHINE / STAGE :- FANUC ROBOT DRILL | OPERATION :- Boring Tapping & Facing

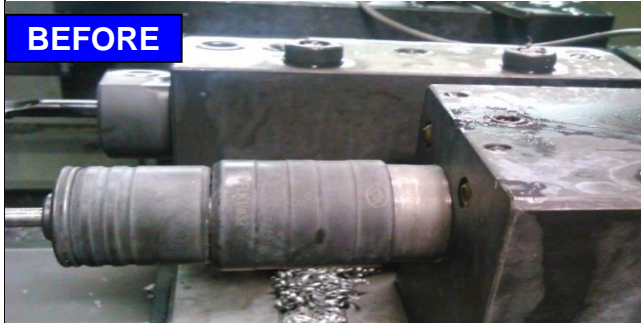
### BEFORE

**PROBLEM / PRESENT STATUS :-** In A-157 Tensioner Line some time getting half thread Component and operator can't Catch the piece Of Part.

WHY 1:- Thread missing problem.

ANS 1:- Due to uneven load on Tapping Holder, Holder jam in back side and Tool length getting short.

ANS 1:- Tapping holder is flexible & flexible Length is Uncontrolled.

Uncontrolled flexibility.

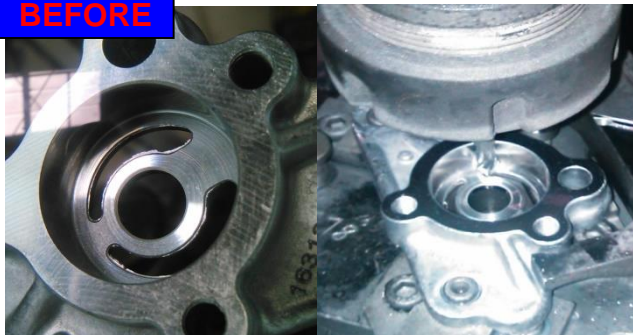
**BEFORE**

**PROBLEM / PRESENT STATUS :-** In A-316 Machine has required 4sec/ Comp to remove The burr from in late out late hole.

- WHY 1:- Process time is more.  
ANS 1:- Due to Burr Removing By Machine.  
WHY 2:- Why Burr Coming.  
ANS 2:- Due to chamfer not available.

**ROOT CAUSE :-** Chamfer not available In Casting.
