TPM CIRCLE NO :-		1	ACTIVITY		KK	QM	PM	JH	SHE	OTP M	DM	E & T	KAIZEN IDEA SHEET																				
TPM CIRCLE NAME :			LOSS NO./STEP																														
Plant : P14		DEPT :	PRODUCTION	RESULT AREA	C	Q	P	P, C	S	M, D	P, C	M																					
CELL :	GRINDING	CELL NAME :	ROTOR GRINDING		M/C STAGE:	YANTHRA			OPERATION:			GRINDING																					
KAIZEN THEME :		KAIZEN IDEA :																															
To avoid carrier plate damage during machining		Carrier plate diameter need to be increased to avoid rotor stuck up							BENCHMARK:		-----																						
									TARGET:		-----																						
									KAIZEN START:		10.12.18																						
									TARGET DATE:		11.12.18																						
									KAIZEN FINISH:		11.12.18																						
									TEAM MEMBERS:																								
									Mr.Mohan V																								
									BENEFITS:-

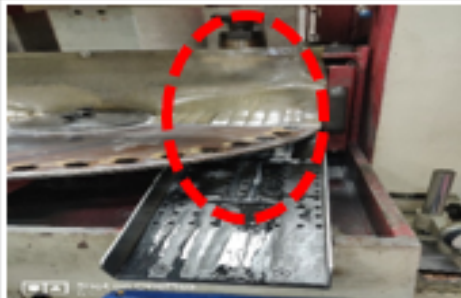
Chance of carrier plate damage is reduced																								
PROBLEM PRESENT STATUS :		COUNTERMEASURE:							KAIZEN SUSTAINANCE <td colspan="2"></td>																								
Rotor gets stuck in carrier plate during machining		Provided a roller with support to push the rotor into output bin to avoid feeder damage							WHAT TO DO:																								
									HOW TO DO: ----																								
									FREQUENCY:																								
									SCOPE & PLAN FOR HORIZONTAL DEPLOYMENT																								
									<table border="1"> <thead> <tr> <th>SR. NO</th> <th>CELL/ PRODUCT</th> <th>TDC</th> <th>RESP.</th> <th>STATUS</th> </tr> </thead> <tbody> <tr> <td>1</td> <td>ALL ROTOR</td> <td>11.12.18</td> <td>Prod</td> <td>Close</td> </tr> <tr> <td></td> <td></td> <td></td> <td></td> <td></td> </tr> <tr> <td></td> <td></td> <td></td> <td></td> <td></td> </tr> </tbody> </table>					SR. NO	CELL/ PRODUCT	TDC	RESP.	STATUS	1	ALL ROTOR	11.12.18	Prod	Close

<table border="1"> <thead> <tr> <th>SR.NO.</th> <th>PLANT</th> <th>WHEN</th> <th>WHOM</th> <th>STATUS</th> </tr> </thead> <tbody> <tr> <td></td> <td></td> <td></td> <td></td> <td></td> </tr> <tr> <td></td> <td></td> <td></td> <td></td> <td></td> </tr> <tr> <td></td> <td></td> <td></td> <td></td> <td></td> </tr> </tbody> </table>					SR.NO.	PLANT	WHEN	WHOM	STATUS															
SR.NO.	PLANT	WHEN	WHOM	STATUS																													
Why2:-Rotor doesn't fall in output bin after machining																																	
Why3:- Part stuck in plate																																	
ROOT CAUSE		RESULTS:

Part gets stuck in carrier plate due to burr fold after machining		No chance of carrier plate damage																															
REGISTRATION NO.:																																	
DATE:																																	
REGISTERED BY:																																	
MANAGER SIGN:		Mr. Manas Kumar Dey
