TPM CIRCLE NO :-	ACTIVITY	KK	QM	PM	JH	STE	OT	DM	E&T	KAIZEN IDEA SHEET KAIZEN NO:-																										
	TPM CIRCLE NAME :	LOSS NO. / STEP	10																																		
	DEPT :- Maint.	RESULT AREA	P	Q	DEF :- A/B/C	C	D	S	M																												
CELL :-	CELL NAME:-	MACHINE / STAGE :-							OPERATION :-																												
KAIZEN THEME :- safety		IDEA :- 240 volt ac supply conector of hydraulic power pack radiator fan covered.																																			
WIDELY/DEEPLY: -during cleaning hydraulic powerpack, operator may Cause an electric shock of 220 volt ac supply due to Open conector.		COUNTERMEASURE:- now this open conector mounted inside the box.				<table border="1"> <tr><td>BENCHMARK TARGET</td><td></td></tr> <tr><td>KAIZEN START</td><td>25.12.17</td></tr> <tr><td>KAIZEN FINISH</td><td>25.12.17</td></tr> <tr><td colspan="2">TEAM MEMBERS:- .amit pandey</td></tr> <tr><td colspan="2"> </td></tr> <tr><td colspan="2"> </td></tr> <tr><td colspan="2">BENEFITS :- operator moral increased prevent accident case.</td></tr> <tr><td colspan="2"> </td></tr> <tr><td colspan="2">KAIZEN SUSTENANCE</td></tr> <tr><td colspan="2"> </td></tr> <tr><td colspan="2">WHAT T

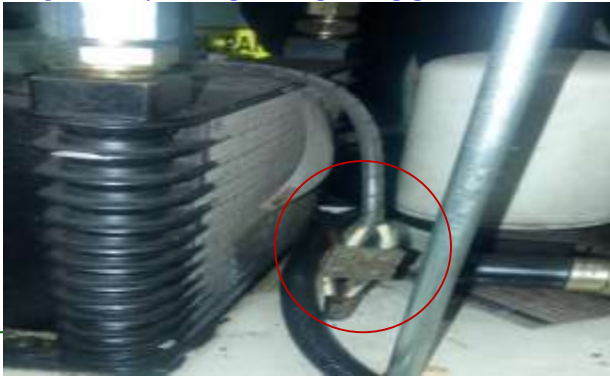
BENCHMARK TARGET																																					
KAIZEN START	25.12.17																																				
KAIZEN FINISH	25.12.17																																				
TEAM MEMBERS:- .amit pandey																																					
BENEFITS :- operator moral increased prevent accident case.																																					
KAIZEN SUSTENANCE																																					
WHAT TO DO :-																																					
HOW TO DO :-																																					
FREQUENCY :-																																					
PROBLEM / PRESENT STATUS :-

WHY WHY ANALYSIS :- WHY :-danger of 220 v ac supply. WHY:-radiator fan supply conector open condition WHY:-poor manufacturer design ROOT CAUSE :-poor manufacturer design.		RESULT :- <hr/>																																			
REGISTRATION NO&DATE:		<table border="1"> <tr><th colspan="5">COST INCURRED FOR MAKING KAIZEN</th></tr> <tr> <th>MATERIAL COST RS.</th> <th>LABOUR COST RS.</th> <th colspan="3">TOTAL COST RS.</th> </tr> <tr> <td>0/-</td> <td>0/-</td> <td colspan="3">0/-</td> </tr> </table>										COST INCURRED FOR MAKING KAIZEN					MATERIAL COST RS.	LABOUR COST RS.	TOTAL COST RS.			0/-	0/-	0/-
