KAIZEN IDEA SHEET
F/IMS/05

CELL: A529 **CELL NAME:** Oil Pump assy **MACHINE / STAGE:-** Flushing Machine **OPERATION:** Flushing

KAIZEN THEME: To Eliminate the Impression mark on oil Pump body

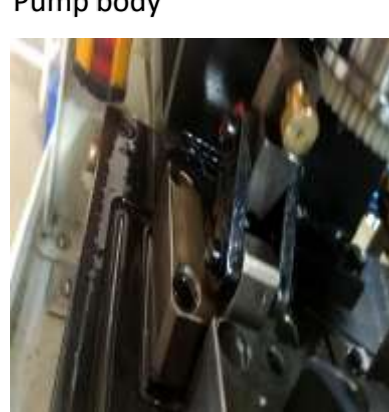
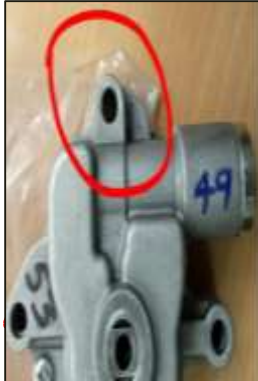
BEFORE

PRESENT STATUS:- Impression mark on oil Pump body

- Why 1 :** Impression mark found on body.
- Why 2 :** At Advik during flushing stage clamping mark observed .
- Why 3 :** Clamping Bush flat face damaged.
- Why 4 :** Clamping Bush came down
- Why 5 :** Clamping Bush was loosened

ROOT CAUSE:- Screw loosened and came down which leads to Impression mark over Pump.

COUNTERMEASURE:- 1] Damaged Clamping Bush replaced with new one & retightened rigidly
2] “Lock-nut” needs to implement in clamping fixture to avoid Bush loosen and came down

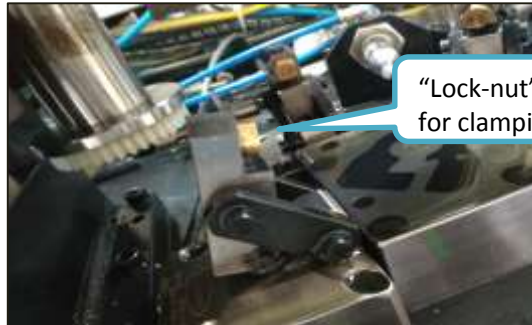
AFTER

“Lock-nut” provided for clamping fixture.

WHAT TO DO : Provided Lock Nut.
