KAIZEN IDEA SHEET

CELL NAME: Tensioner

MACHINE / STAGE: ACE COLT 1

KAIZEN THEME : To eliminate burr spillage at Tensioner machining stage.

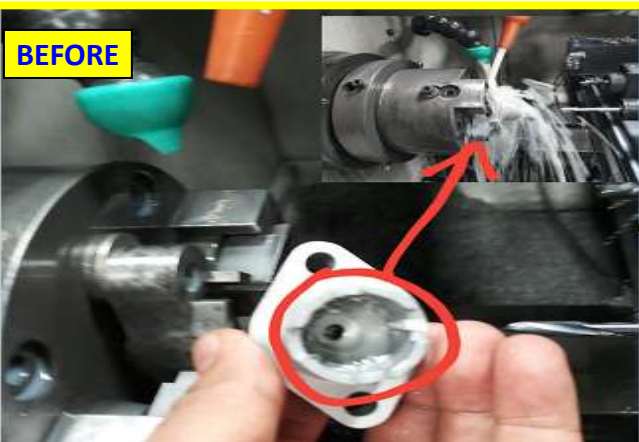
BEFORE

PRESENT STATUS: After machining burr spillage from air cleaning booth .

Why1: After machining burr spillage from air cleaning booth .

Why2: Burr gets out from the body during air cleaning in booth.

Why3: Burr is not getting out from ID after machining stage (Op 10).

ROOT CAUSE:- Burr is not getting out from ID after machining stage (Op 10).
