TPM CIRCLE NO :-		ACTIVITY	KK	QM	PM	JH	SHE	OTPM	DM	E & T	KAIZEN IDEA SHEET
TPM CIRCLE NAME :		LOSS NO./STEP									
DEPT :	Quality	RESULT AREA	C	Q	P	P,C	S	M, D	P, C	M	
CELL :-	Assembly	CELL NAME :	A529 PRV Assembly		M/C STAGE:	PRV Assembly.		OPERATION:	Inspection

To provide Flush pin gauge for Circlip fitment in PRV Housing assembly.  
 For checking Circlip proper fitment in A529 PRV assembly Flush pin gauge to be provided.  
 BENCHMARK:  
 TARGET:  
 KAIZEN START:

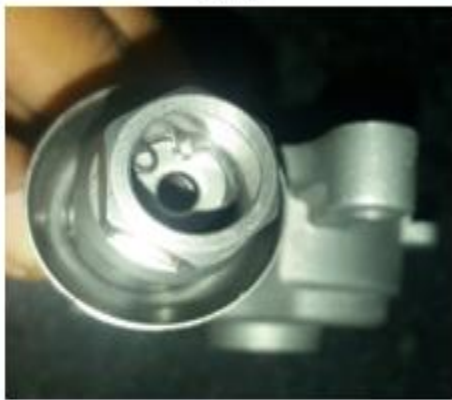
PROBLEM PRESENT STATUS : COUNTERMEASURE:  
 For present only visual inspection is doing no gauge available for checking the proper fitment of the circlip.using Vernier for inspection.  
 Flush pin gauge is provided for fitment inspection.  
 TARGET DATE: 22.12.2018  
 TEAM MEMBERS:

Why1:- Circlip fitment bend found in final inspection.  
 Why2:- After fitment visual inspection is doing for circlip fitment.  
 Why3:- Guage not available in assembly station.

For present only visual inspection is doing no gauge available for checking the proper fitment of the circlip.
