KAIZEN THEME : To improve detectability of NG Part.

IDEA :- Provide a attribute gauge for machine operator.

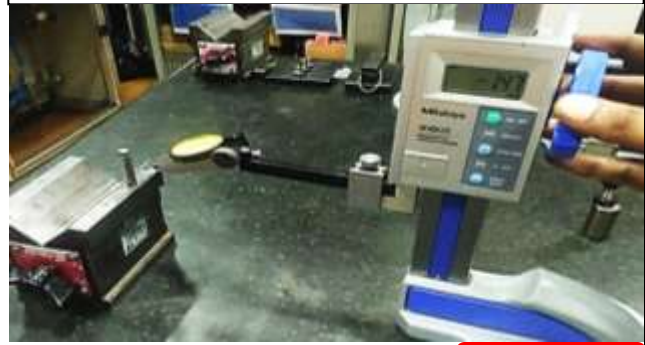
Before

Problem present status :- Dimn. 36.61 of A-271 is not checked by operator only line inspector is checking the Dimn.

WHY1 –Dimn. 36.61 of A-271 is not checked by operator only line inspector is checking the Dimn.

Why 2 :- No attribute (Relation) gauge is provided to operator for checking the Dimn.

ROOT CAUSE :- Attribute gauge (relation gauge) is not available on Machine

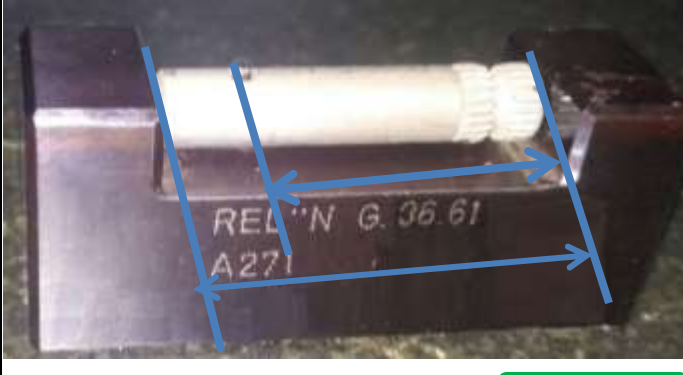
After

COUNTERMEASURE:- Now we will provide relation gauge for checking the particular Dimn.

- 1.Chance of rejection flow to next operation reduce
- 2.Inspection time reduce
- 2.Now operator easily check the dimn.
