CELL :- M/C Shop | **CELL NAME:-** Oil Pump | **MACHINE / STAGE :-** Rotary washing | **OPERATION :-** Cleaning

KAIZEN THEME :- To reduce MTTR.

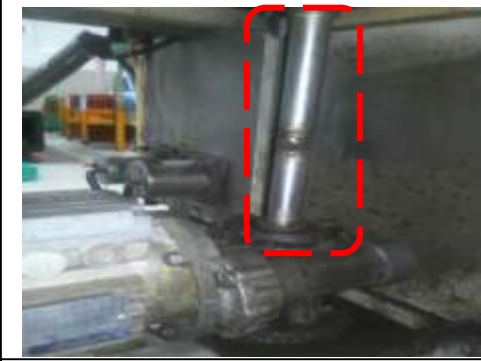
BEFORE

PROBLEM / PRESENT STATUS :- Time required for the removal of Gear box is more i.e 70 minutes

WHY - WHY ANALYSIS :-
Why1:- Gear box removal time is more.
Why2:- Removal accessories more
Why3 :-Single piece of shaft connected b/w gear box & Rotary unit.

ROOT CAUSE :- Single piece of shaft

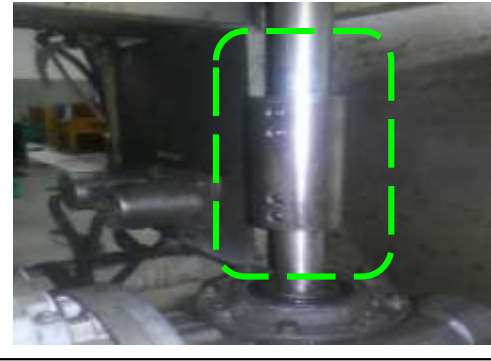
AFTER

COUNTERMEASURE:- Provided coupling in b/w the shaft of gear box & rotary unit.

IDEA :- Coupling to be Provided.
