CELL :- Tensioner CELL NAME:- A-157 MACHINE / STAGE :- Mazak (QUICK TURN 6G) OPERATION :- Boring Tapping & Facing

### KAIZEN THEME :-

To eliminate Thread defect Problem.

CELL :- oil Pump | CELL NAME:- A-316 | MACHINE / STAGE :- FANUC ROBOT DRILL | OPERATION :- Boring Tapping & Facing

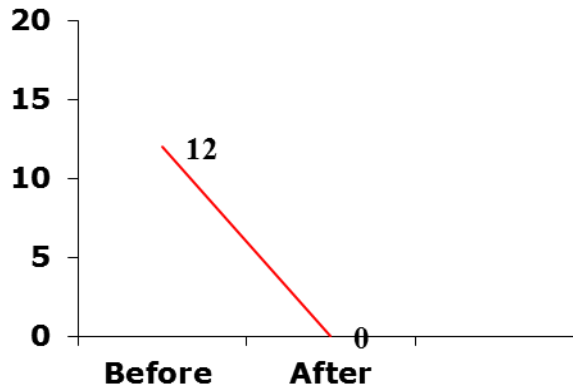
**PROBLEM / PRESENT STATUS :-** In A-157 Tensioner Line some time getting half thread Component and operator can't Catch the piece Of Part.

WHY 1:- Thread missing problem.

ANS 1:- Due to uneven load on Tapping Holder, Holder jam in back side and Tool length getting short.

**RESULT :-** Customer Complaint.

**COUNTERMEASURE:-** Proximity sensor attached On Tapping Holder if the holder jam in back side That time sensor work and machine get Emerge.

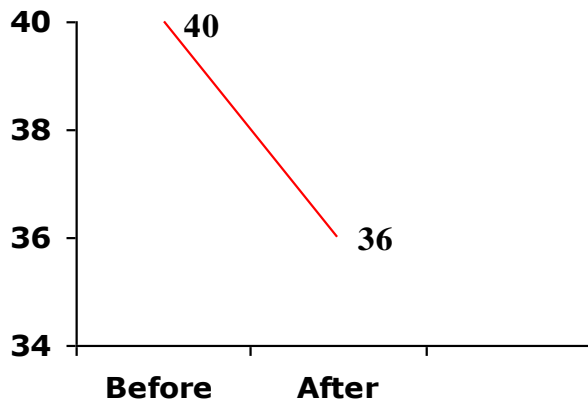
**PROBLEM / PRESENT STATUS :-** In A-316 Machine has required 4sec/ Comp to remove The burr from in late out late hole.

- WHY 1:- Process time is more.  
ANS 1:- Due to Burr Removing By Machine.  
WHY 2:- Why Burr Coming.  
ANS 2:- Due to chamfer not available.

**ROOT CAUSE :-** Chamfer not available In Casting.

**RESULT :-** Cycle Time Reduce.

**COUNTERMEASURE:-** Provided Chamfer in In – Late Out-Late hole, Now We not using tool in Machine.
