KAIZEN IDEA SHEET
F/IMS/05

CELL: A529 **CELL NAME:** Oil Pump assy **MACHINE / STAGE:-** Flushing Machine **OPERATION:** Flushing

KAIZEN THEME: To Eliminate the Impression mark on oil Pump body

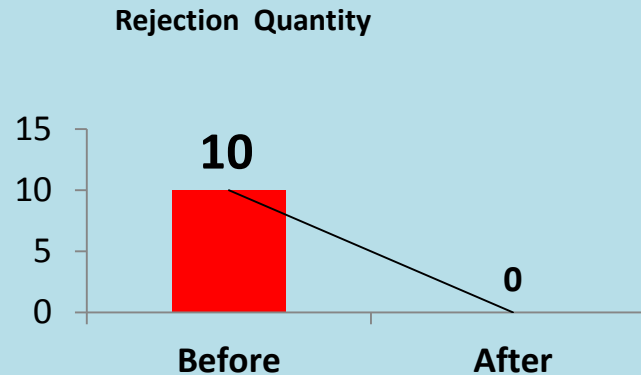
PRESENT STATUS:- Impression mark on oil Pump body

- Why 1 :** Impression mark found on body.
- Why 2 :** At Advik during flushing stage clamping mark observed .
- Why 3 :** Clamping Bush flat face damaged.
- Why 4 :** Clamping Bush came down
- Why 5 :** Clamping Bush was loosened

ROOT CAUSE:- Screw loosened and came down which leads to Impression mark over Pump.

COUNTERMEASURE:- 1] Damaged Clamping Bush replaced with new one & retightened rigidly
2] “Lock-nut” needs to implement in clamping fixture to avoid Bush loosen and came down

“Lock-nut” provided for clamping fixture.
