TPM CIRCLE NO :-04	ACTIVITY	KK	QM	PM	JH	SHE	OT	DM	E&T
TPM CIRCLE NAME : Oil pump	LOSS NO. / STEP								
DEPT : Machine Shop	RESULT AREA	P	Q	DEF:-A		C	D	S	M

CELL :- A 247	CELL NAME: Bracket	MACHINE / STAGE :- SPM	OPERATION- Machining
---------------	--------------------	------------------------	----------------------

KAIZEN THEME - : To Avoid Coolant Overflow.

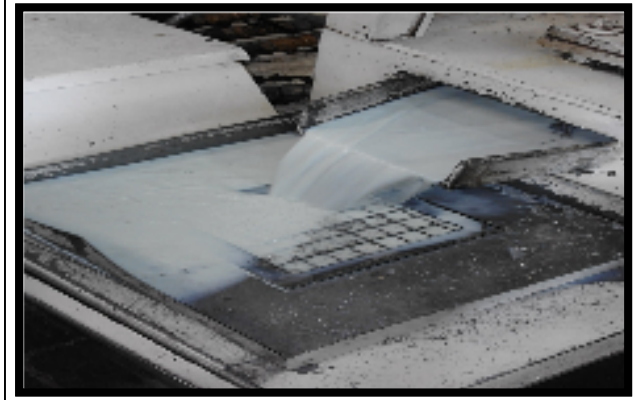
PROBLEM / PRESENT STATUS :- Coolant Overflow due to Tray Height Less.

WHY - WHY ANALYSIS :-
Why 1 :- Coolant Overflow in Bkt SPM
Why 2 :- Less Height of Coolant Tray.
Why 3 :- Basic Design of Machine.

ROOT CAUSE :- Basic Design of Machine.

COUNTERMEASURE:- Coolant Tray Height Increased with replacing of new Guard.

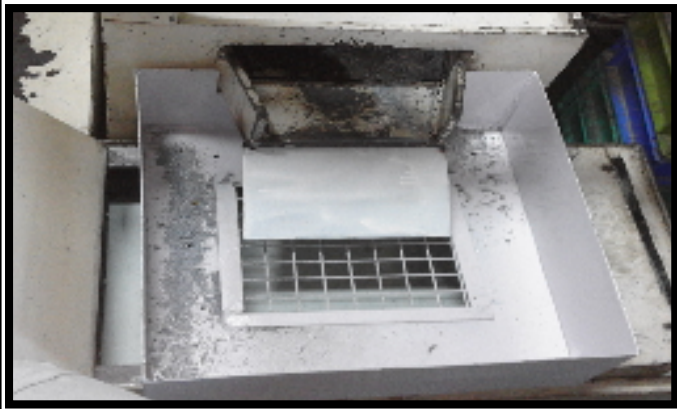
AFTER

RESULT :-
 1)Coolant Overflow Problem Resolved.

IDEA :-Guard height Increasing.
