TPM CIRCLE NO :-05	ACTIVITY	KK	QM	PM	JH	SHE	OT	DM	E&T				
		TPM CIRCLE NAME: - Innovation	LOSS NO. / STEP												
		DEPT :-QA	RESULT AREA	P	Q	A		C	D	S	M				
CELL:-Assembly	CELL NAME:- Fuel cock	MACHINE / STAGE :-Off mode leakage testing machine					OPERATION :- OFF mode leakage testing								
KAIZEN THEME :-To reduce the possibility of customer complaints due to spot facing missing.		IDEA :- Provide the provision.													
Problem present status :- Possibility of customer complaints due to to spot facing missing in fuel cock assy.		COUNTERMEASURE:-Spot groove depth set with read switch for capturing the depth of spot if spot miss part comes on this stage then cycle will not operate.					BENCHMARK		Chance of CC						
							TARGET		No chance of CC						
							KAIZEN START		20.07.17						
							TDC		30.07.17						
							KAIZEN FINISH		01.08.17						
							TEAM MEMBERS : Rajesh Kumar, Gurpreet Singh

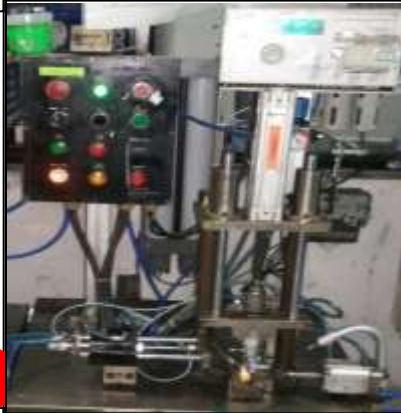
**WHY 1:-**Customer complaints may occurred due to to spot facing missing.

**WHY 2:-**Chance of part skip to customer end without spot facing.

**WHY 3:-**No provision for capturing the spot facing missing part.

**ROOT CAUSE :-**No provision for capturing spot facing missing part..

BENEFITS :- No chance of customer complaints								
							KAIZEN SUSTENANCE								
							WHAT TO DO:-Check the working condition of proximity sensor								
							HOW TO DO:- Visual checking								
							FREQUENCY :- Daily basis.								
							SCOPE & PLAN FOR HORIZONTAL DEPLOYMENT								
							SR. NO.		CELL		TARGET		RESPONSIBILITY		STATUS
							1		P-15		----		CQA
